**Out-of-plane Behavior of
Prototype Interlocking
Plastic-block Wall with Opening
Under Harmonic Loading**

A thesis submitted in partial fulfillment for the
degree of Master of Science

Department of Civil Engineering

2020

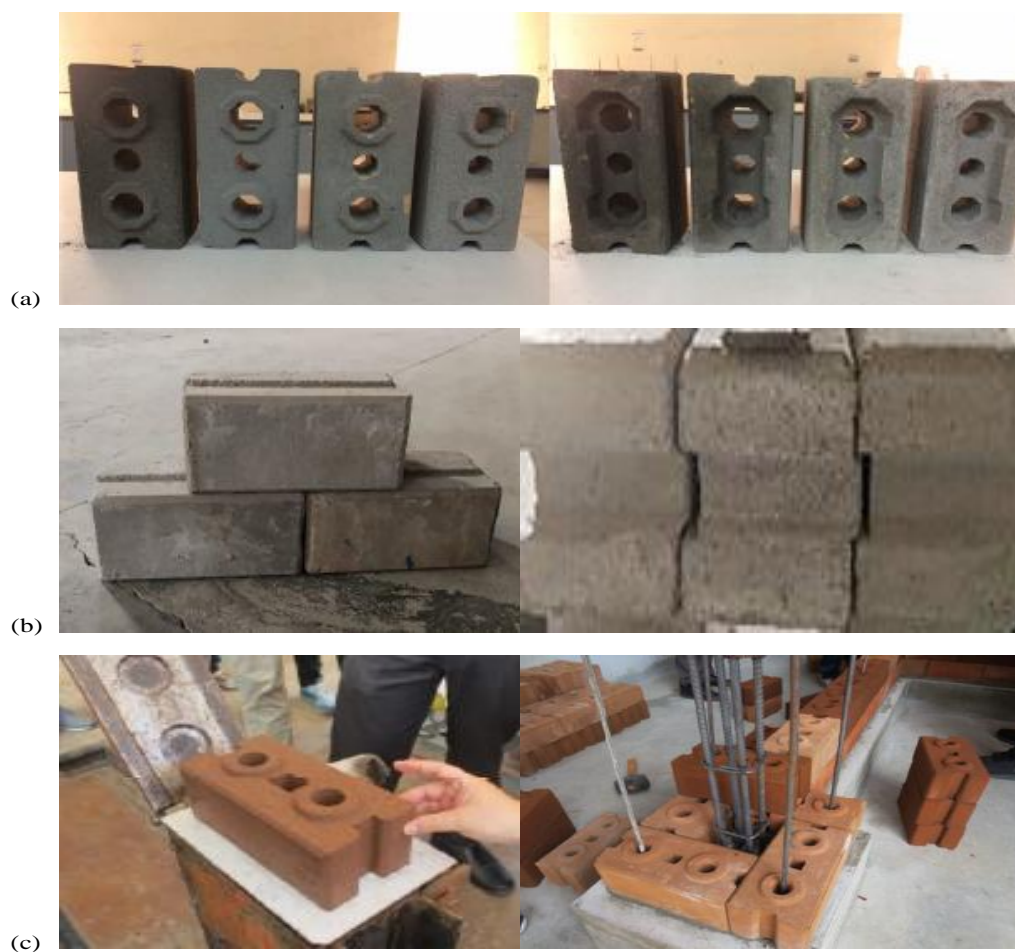
FIGURE 2.7: Various interlocking patterns/techniques for blocks; (a) eco-friendly interlocking block including holes and shapes [27], (b) sliding interlocking block [28], (c) interlocking block including holes to provide steel reinforcement [29]

Shakir et al. [27] constructed innovative eco-friendly interlocking block shown in Figure 2.7(a) made from locally available waste materials like palm oil clinker, palm oil fuel ash, and quarry dust for construction of earthquake resistant houses. Jeslin et al. [28] compared conventional brick and interlocking block shown in Figure 2.7(b) on the basis of strength aspects. The study reported 15%-30% increase in mechanical properties for the case interlocking block. Jan et al. [29] proposed interlocking masonry block construction with steel reinforcement for sustainable housing in Thailand shown in Figure 2.7(c).

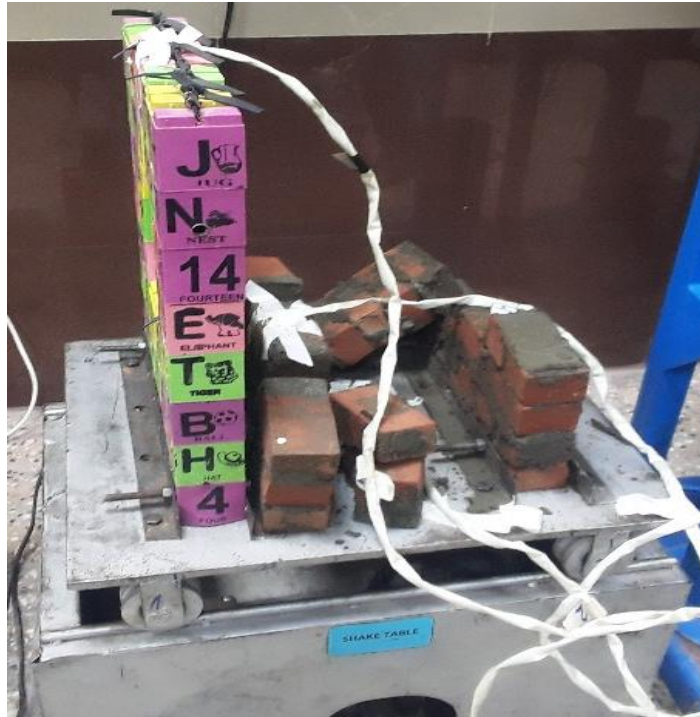
FIGURE 4.4: Failure of unreinforced brick masonry wall with opening during the application of harmonic loading

Hz and during the application of second harmonic loading i.e., 2 Hz, wall suddenly collapsed as shown in Figure 4.4. It is concluded that interlocking plastic-block construction is a potential solution for earthquake resistant housing schemes.
